City of Huntsville

PALM STREET WATER PLANT

CONDITION ASSESSMENT

November 10, 2015

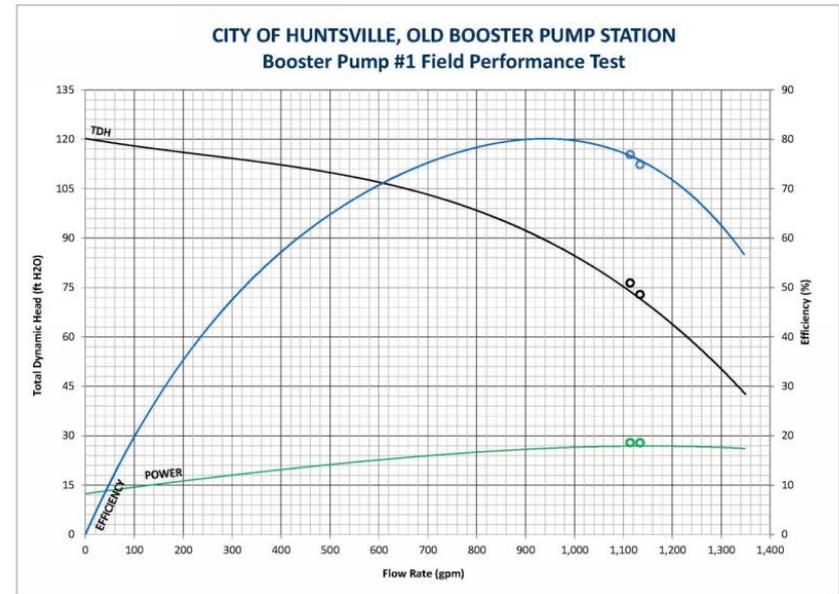
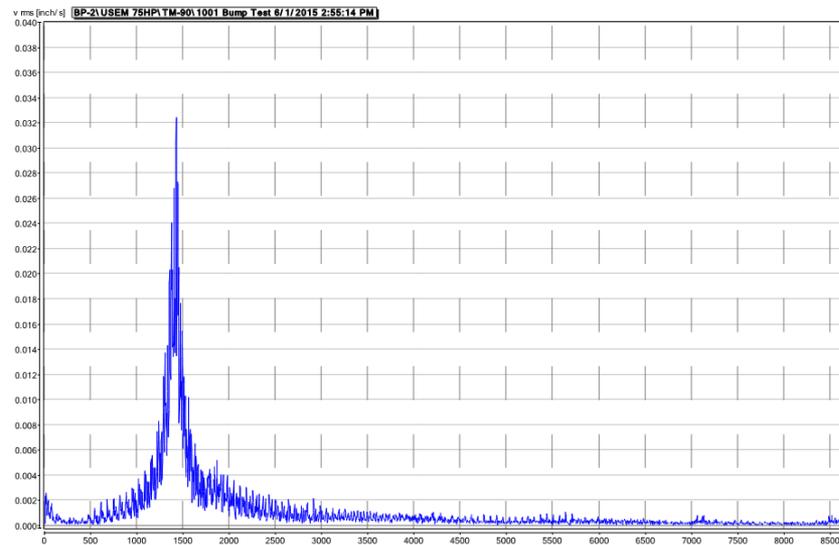
- High vibration, above HI standards
- Coupling guards difficult to remove
- Corroded stuffing box
- Packing gland studs gone on pumps 3 & 4
- Operating on the right side of the curve

Figure 5: MT-90 Bump Test, Reed Frequency at 1,424 cpm, Motor Speed is 1,785 rpm

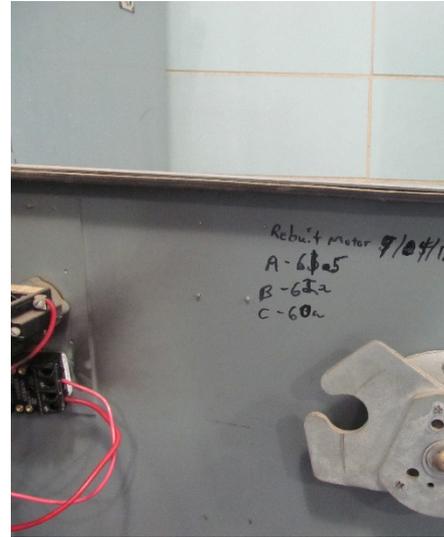
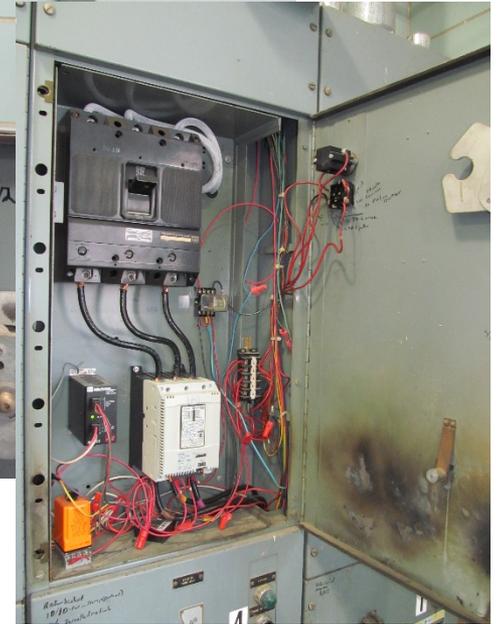
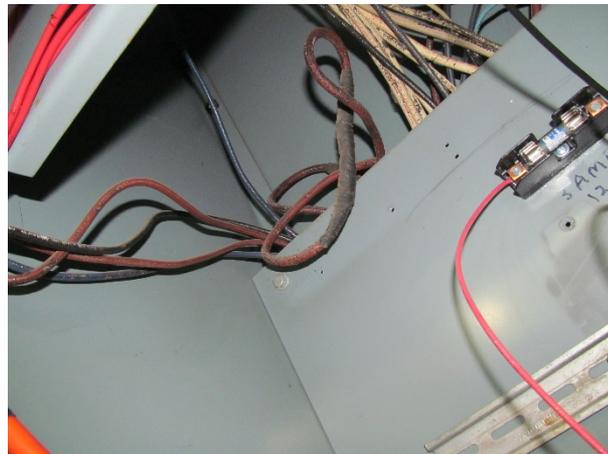
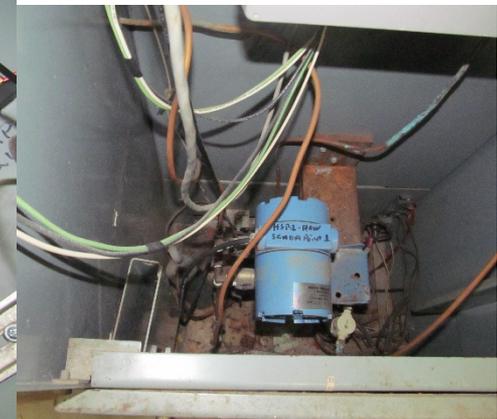
- MCC
 - Original from 1960's
 - Parts no longer available
 - Cloth covered wiring
 - Pump controller obsolete
 - Indications of multiple faults
 - Water piping in MCC
 - Protective characteristics change
- Motors
 - Manufactured in 1960. One has been replaced, others are originals
 - Nameplate indicates asbestos in motors

Electrical Package	
Replace MCCs at both Pump Stations	\$667,000
Reroute Alternate Power conduits at Old Pump Station	\$23,000
Instrumentation/SCADA improvements	\$92,000
Total	\$782,000
Old Pump Station Package	
Replace Pumps and Motors	\$247,000
Repair/Replace Piping and Valves	\$54,000
Structural/HVAC/Miscellaneous Improvements	\$155,000
Total	\$456,000
New Pump Station Package	
Replace Pumps and Motors	\$113,000
Repair/Replace Piping and Valves	\$48,000
Structural/HVAC/Miscellaneous Improvements	\$447,000
Total	\$608,000
<i>Rehab Existing Pump Station Total</i> \$1,846,000

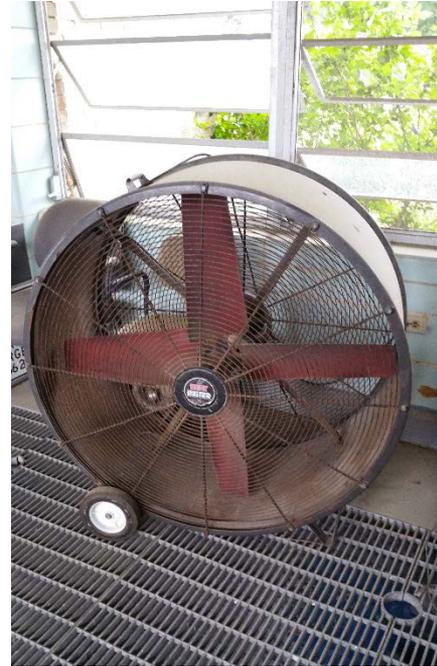
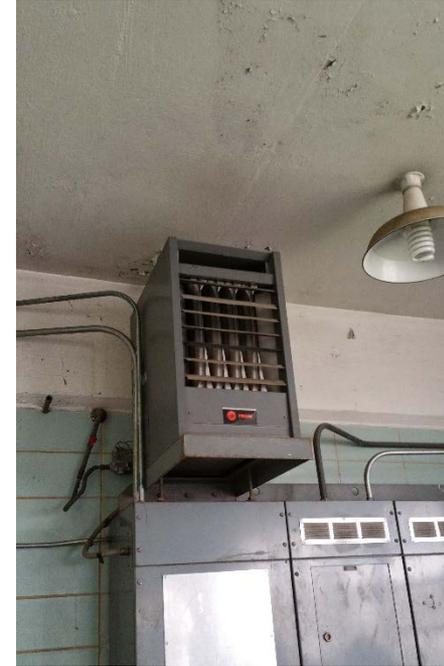
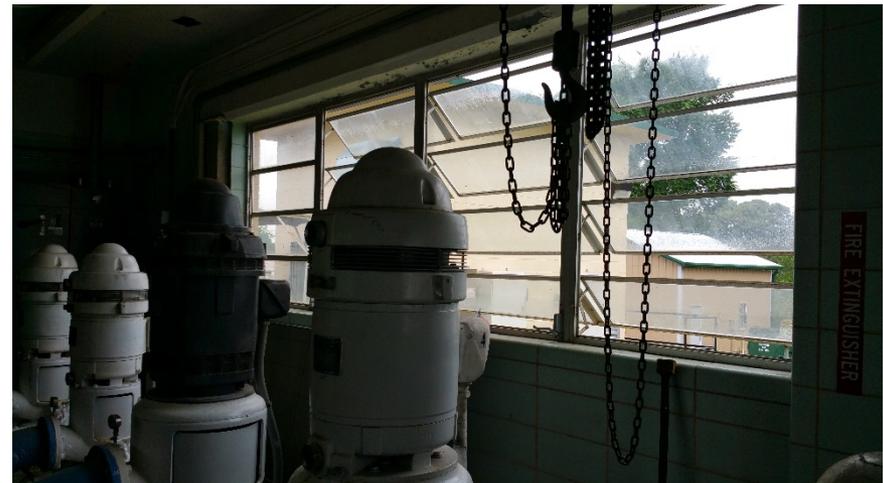
- No permanent mechanical ventilation installed.

- Recommend removing a section of windows on each side of the pump station to install wall-mounted fan and louver.
- Recommend installing another unit heater for redundancy.

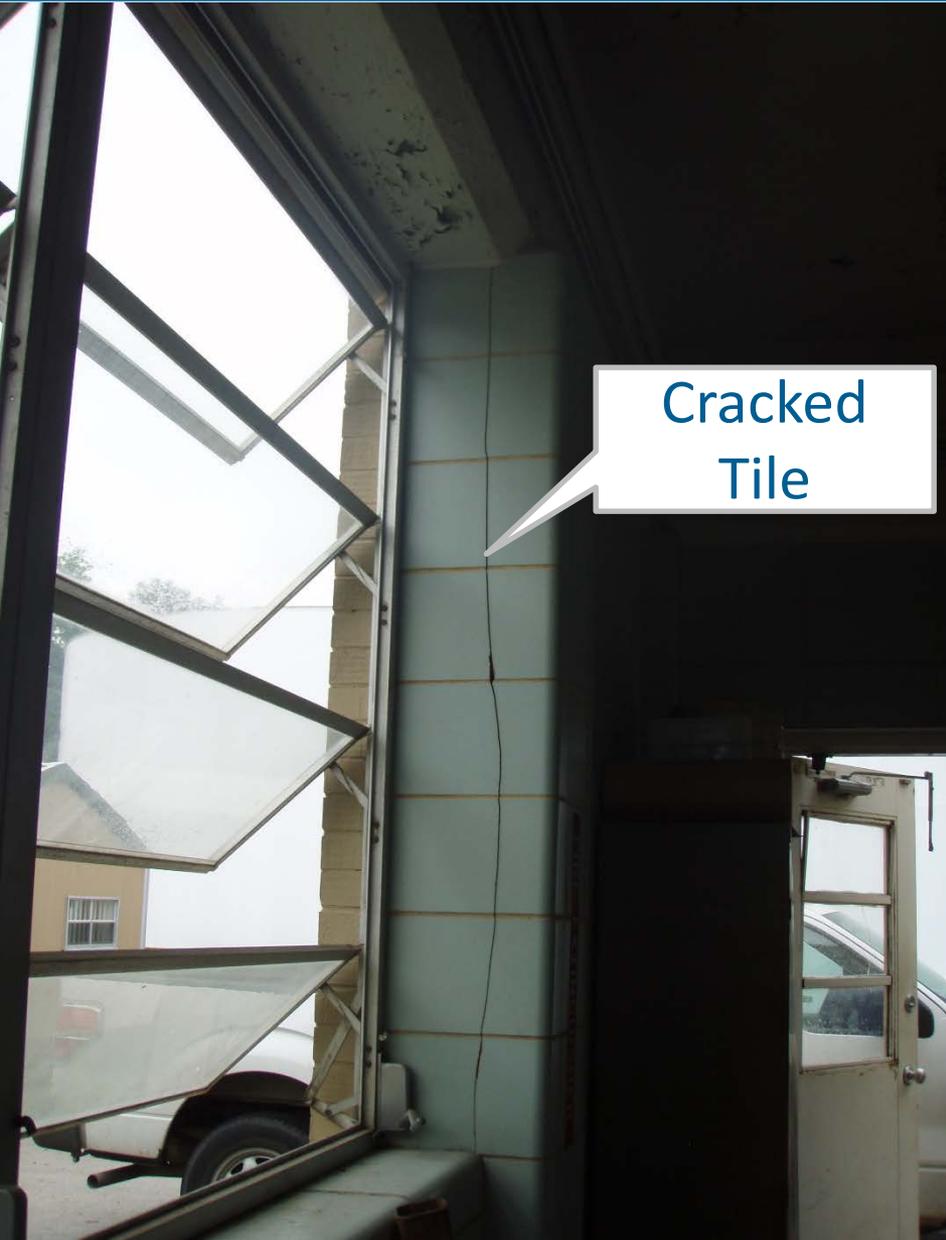
Cracked
Tile

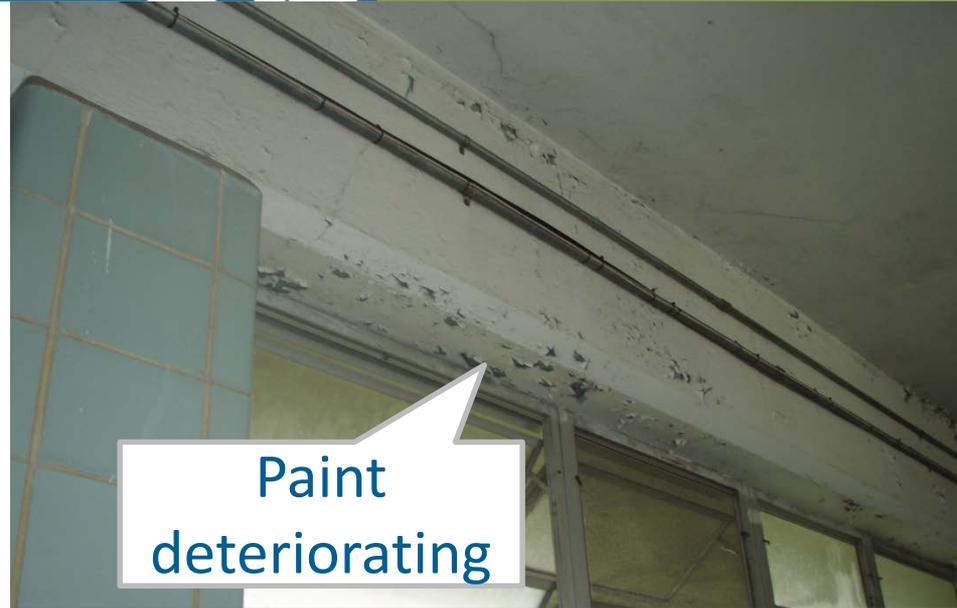
Paint
deteriorating

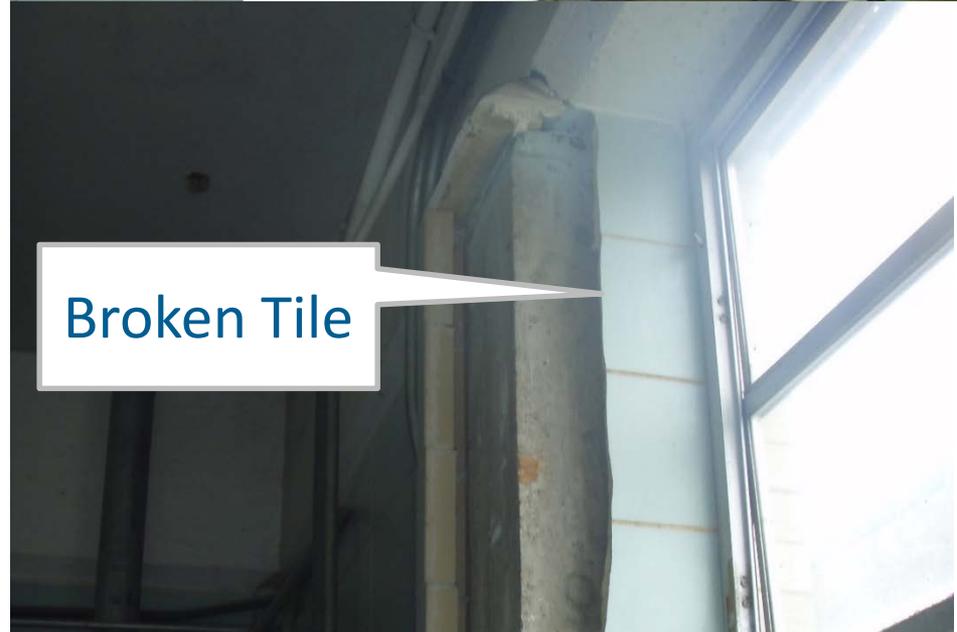
Broken Tile

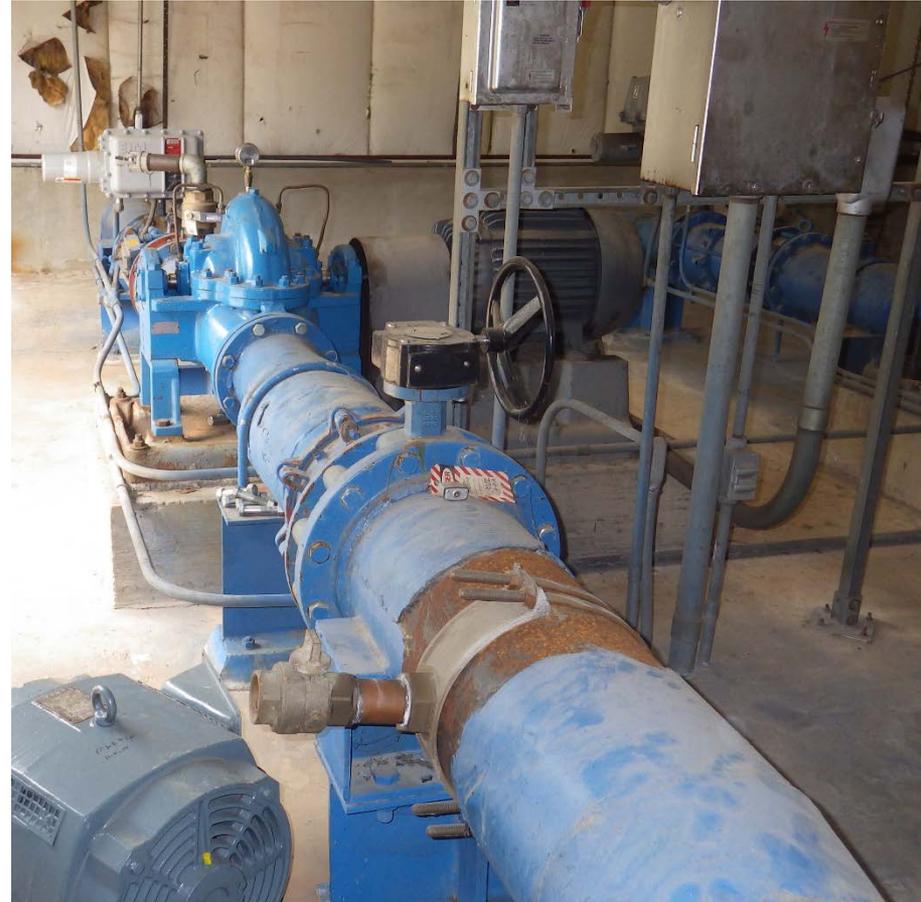
- Signs of corrosion on some of the pumps
- No longer manufacturing this pump.
 - Cast parts unlikely to be available
- BFVs utilized instead of GVs
- Old BFV showed signs of cavitation and was very corroded
- Corrosion at taps
- Tape coating peeling in some locations

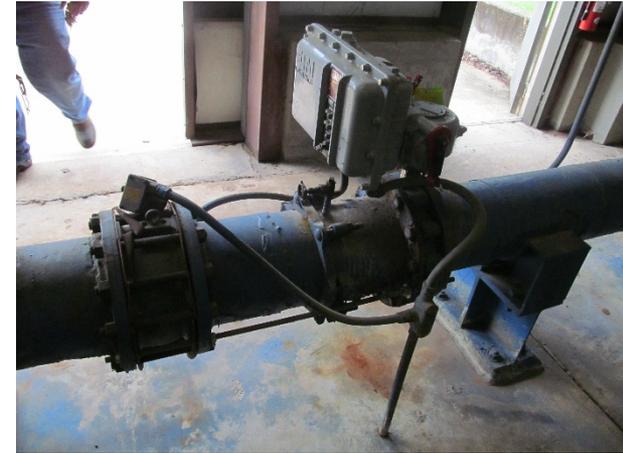
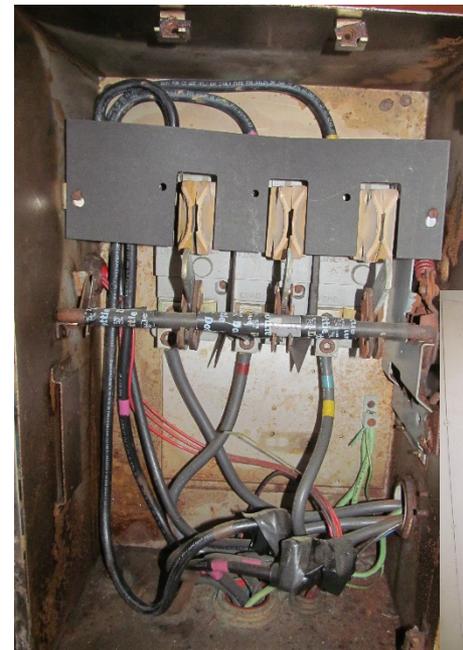
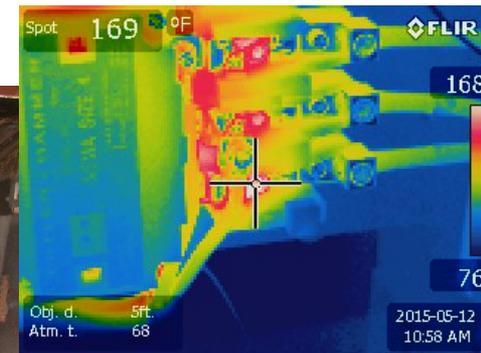
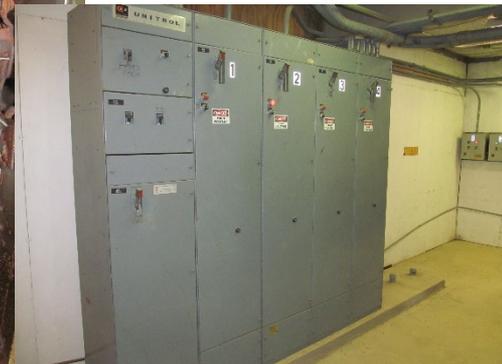
- **MCC & Equipment**
 - Installed mid 1980s, past the life expectancy
 - MCC components becoming hard to find
 - Protection characteristics of equipment changes as it ages
 - Disconnect on pump 1 corroding inside
- **Automatic Transfer Switch (ATS)**
 - Replacement parts will become hard to find
- **Motors**
 - Some have been replaced.
 - Infrared reading have been done
- **Motor Operated Valve (actuators)** are not longer supported. Parts are not available.

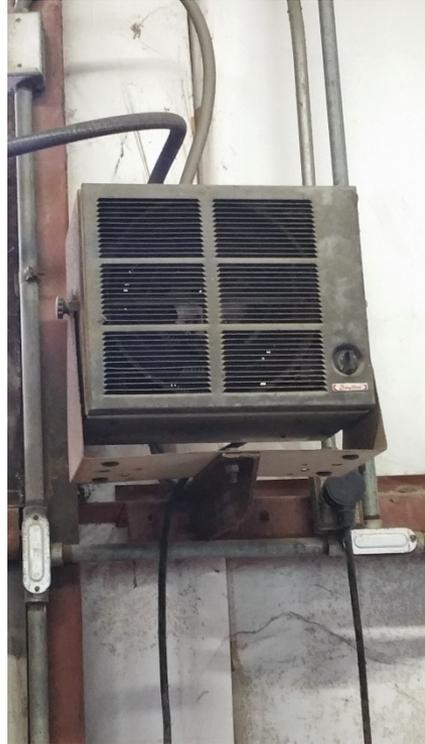
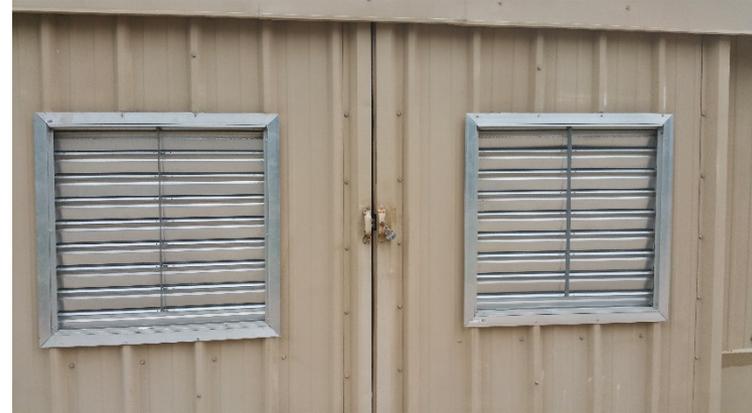
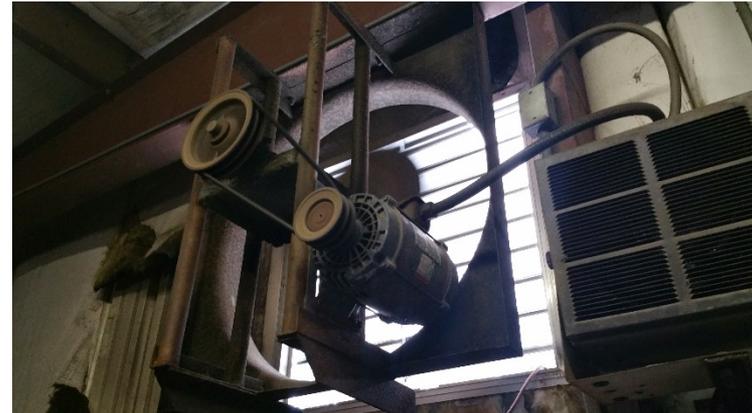
- Unit heater does not work and should be replaced, redundancy is recommended.
- Louvers let water through, recommend combination louver-damper.
- Exhaust fan is nearing end of useful life. Recommend replacing and including wall collar, hood and OSHA guards.

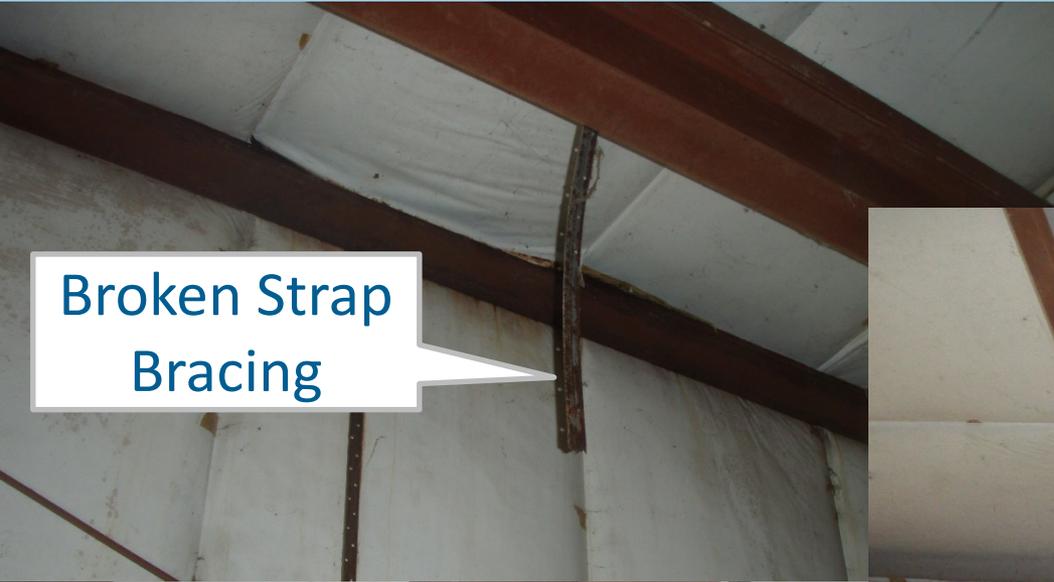
Broken Strap
Bracing

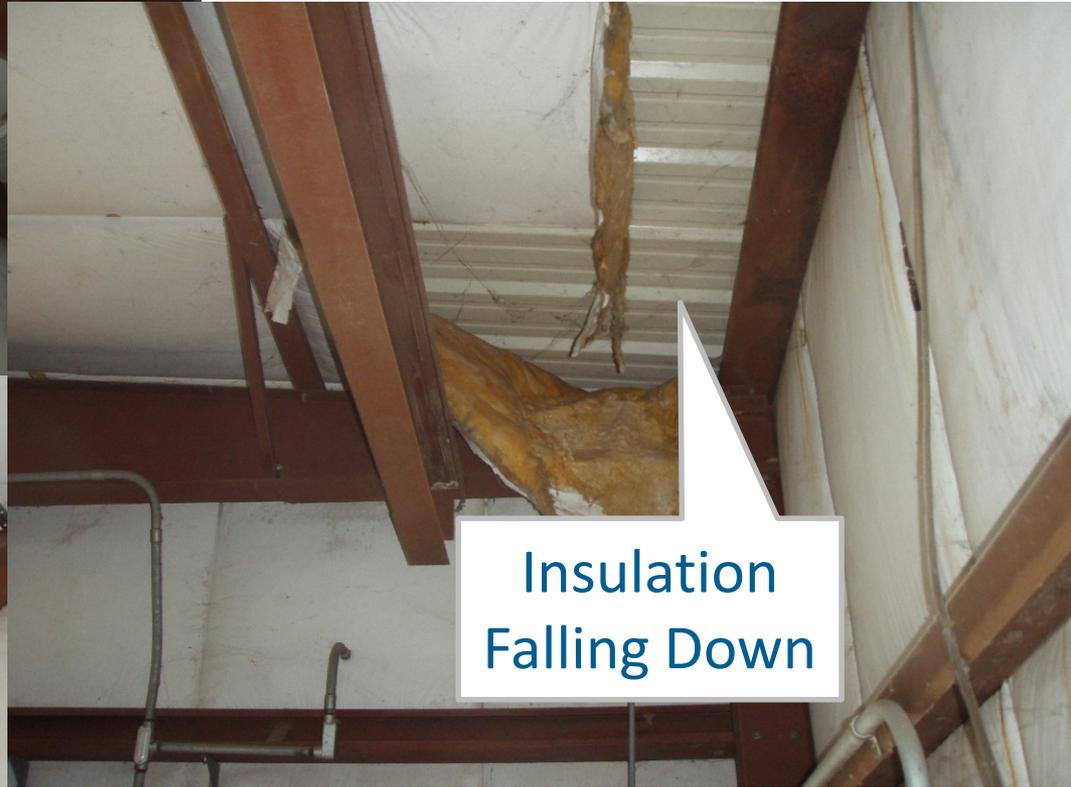
Insulation
Falling Down

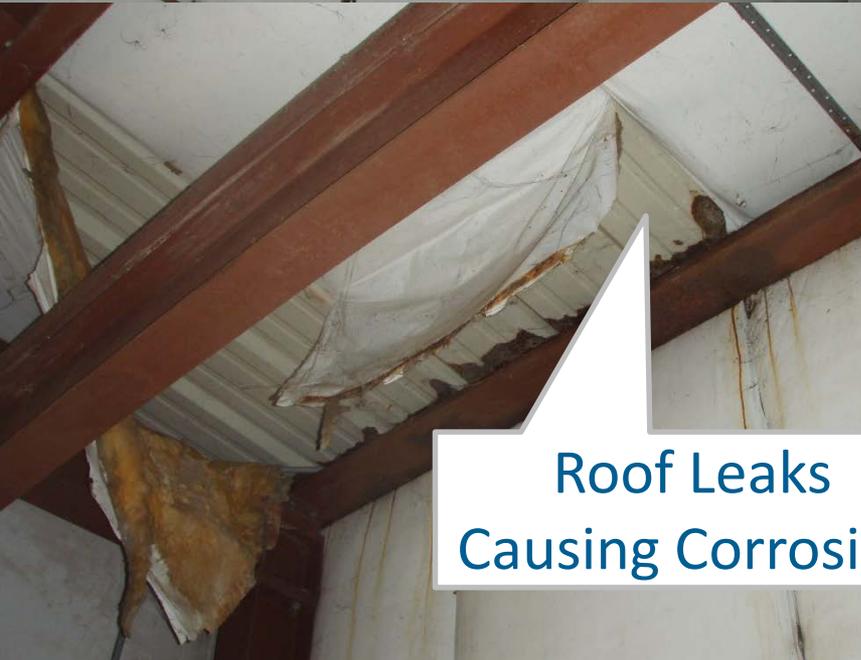
Roof Leaks
Causing Corrosion

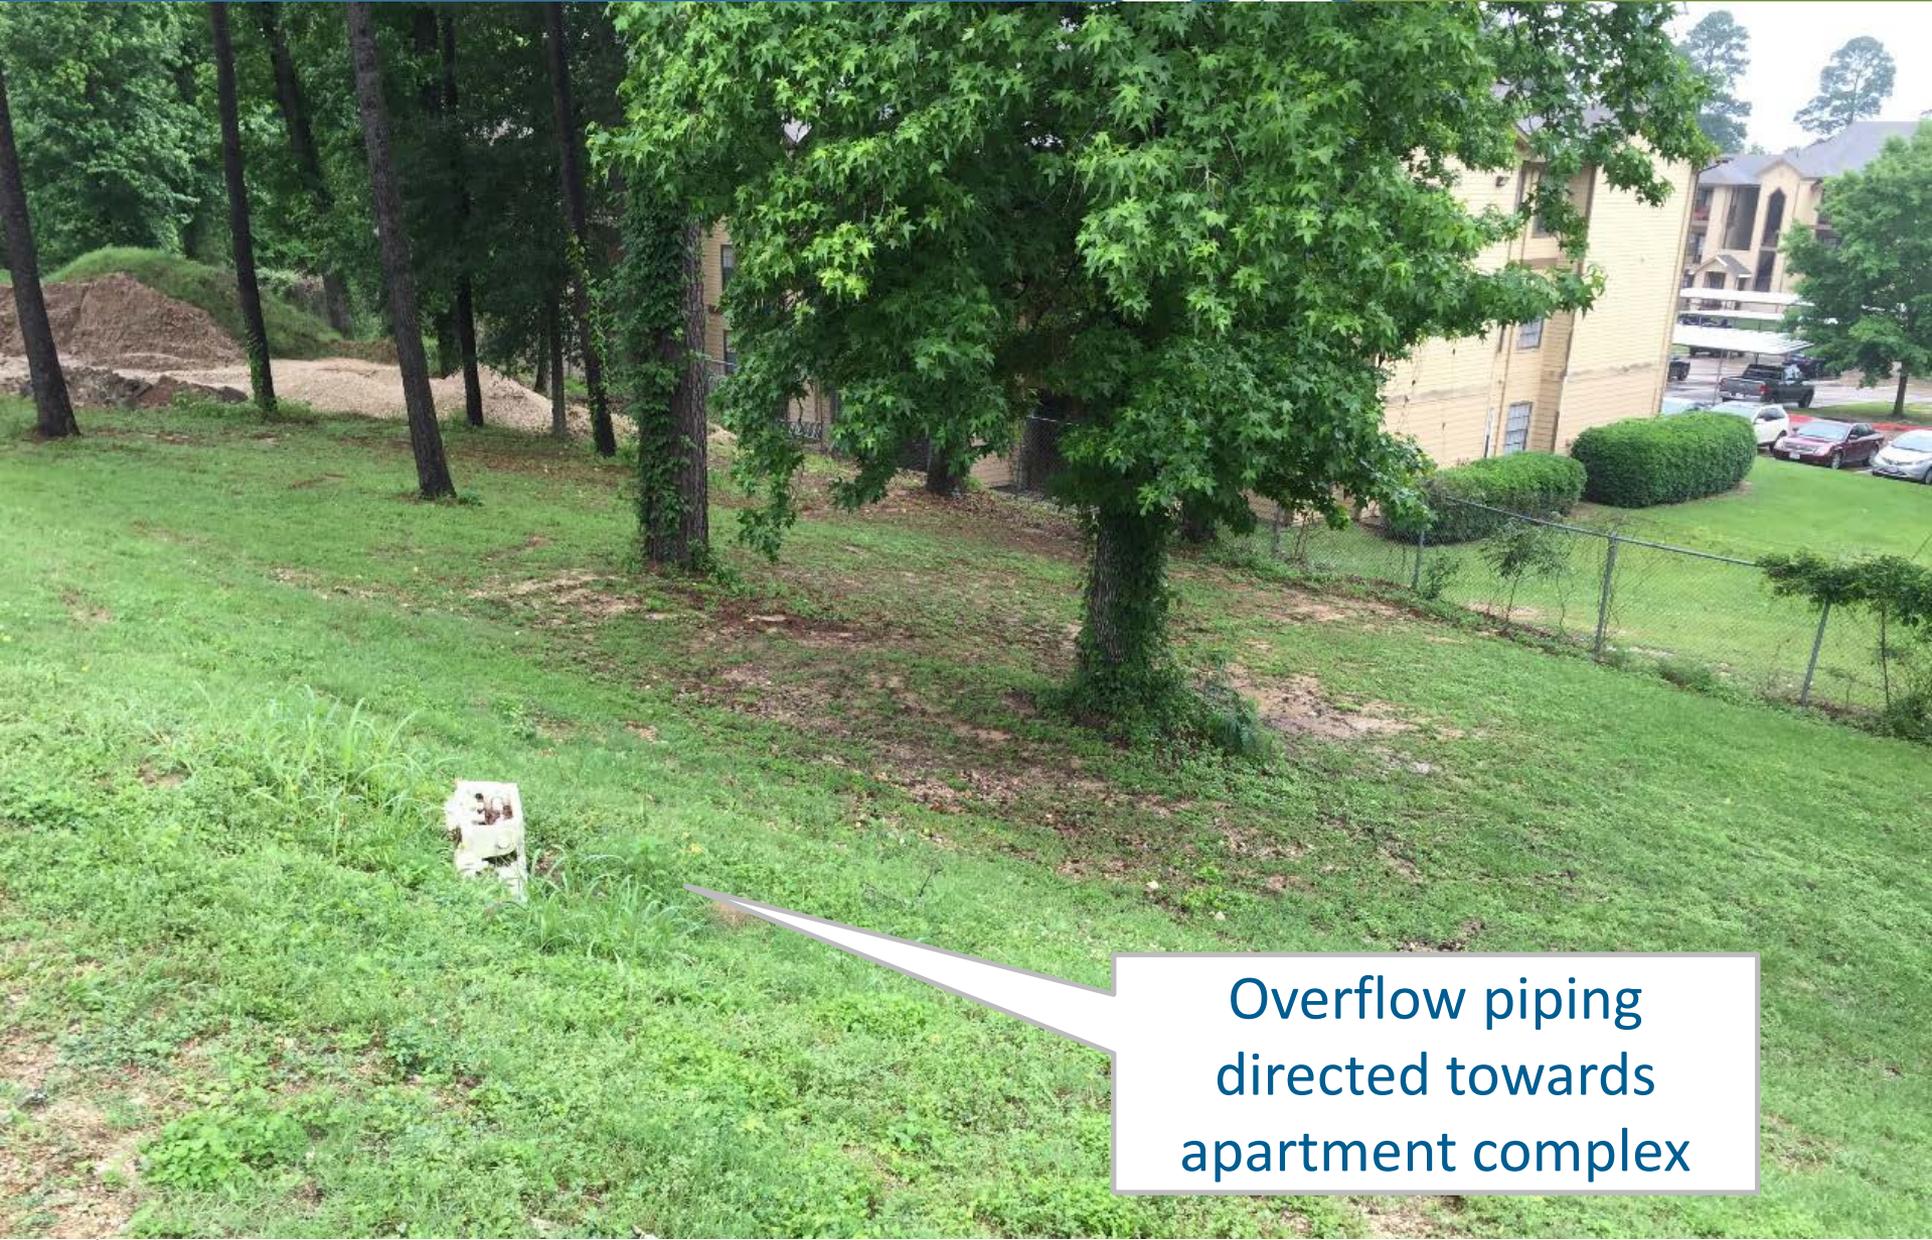
Overflow piping
directed towards
apartment complex
