# **A.J. Brown Wastewater Treatment Plant Condition Assessment**

**November 16, 2015**

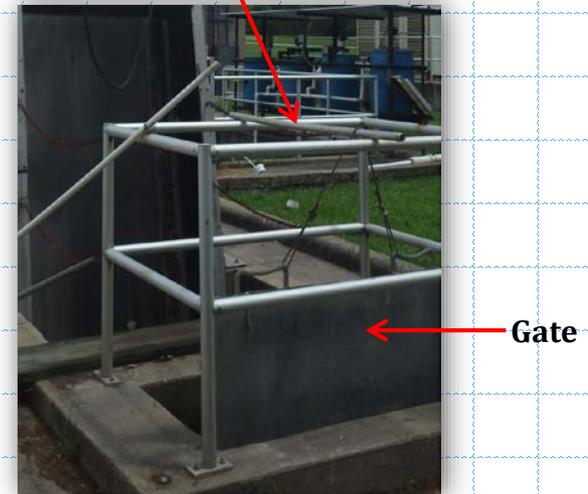
Gate hung on rod

- Existing Conditions
  - Mechanical Screen
    - Screen in good condition
    - Occasional over torquing
  - Inlet Gate
    - Gate hung on a rod supported on the handrails
    - Manually lifted with a crane
  - Manual Bypass Screen
    - Difficult to get the screenings out of the channel
    - Safety Concerns – No handrails upstream and downstream

1. Replace existing inlet gate hung on pole with a slide gate for easier operation
2. Provide handrails at the manual bypass screen

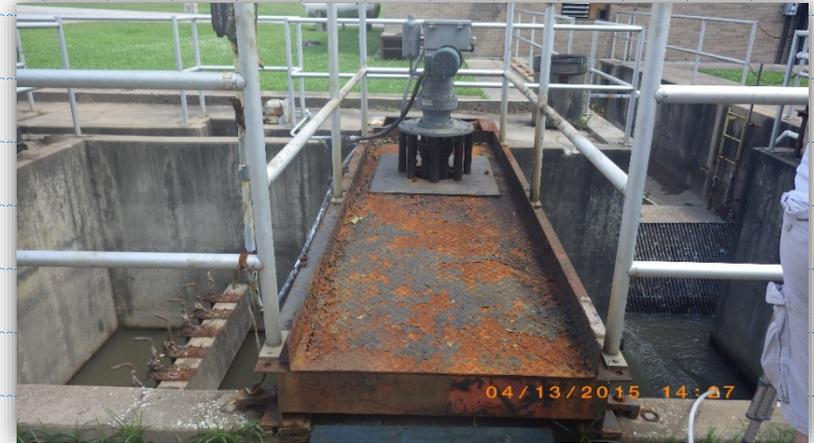
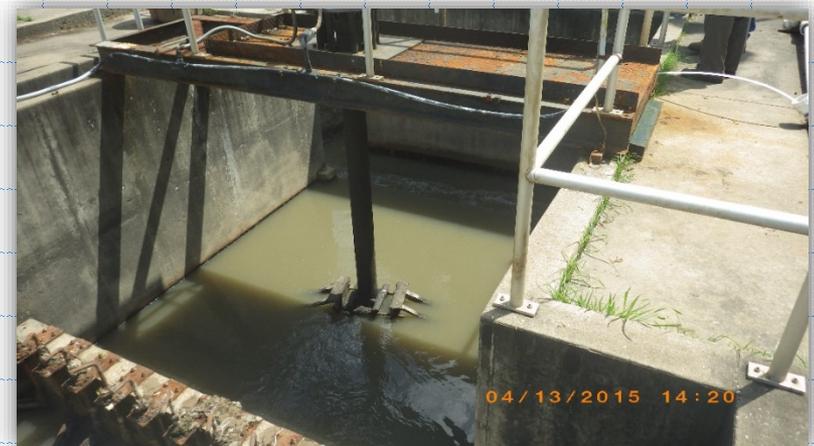
- System functional but reaching end of useful life
    - Corrosion of inlet baffles and screw conveyor

- Flex conduits are corroding
    - Push button station aging at screw & grit motor
    - MCC past life expectancy of 30 years
    - Screw motor shows corrosion

- Railings damaged, safety hazard
    - Bridge/ walkway corroded
    - Some handrails broken
    - Concrete structure in good condition

1. Replace motor access bridge/ walkway
2. Repair damaged/ broken railings
3. Replace MCC and push button at screw and grit motor

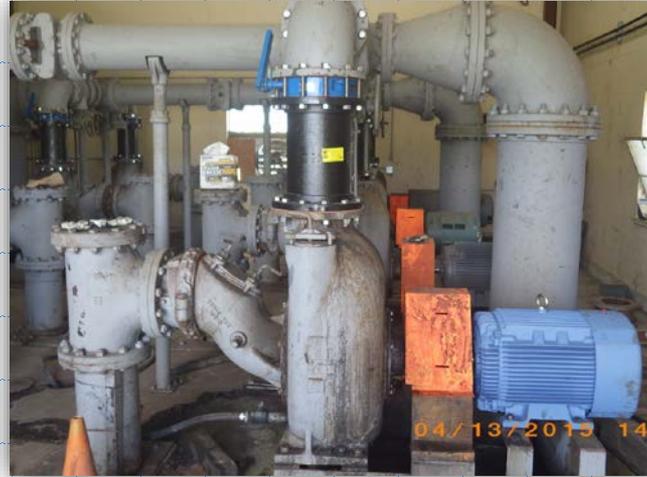
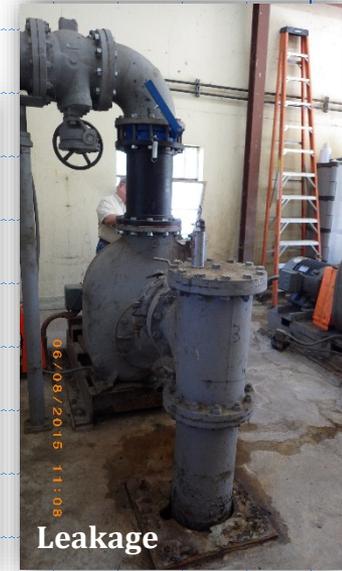
- Seals are leaking
    - Volutes show severe wear and tear and leakage
    - All motors have been (except pump no. 1) have been replaced over the years
    - Frequently have to be taken out of service for repair
    - Pumps are past their useful life

- No proper drainage inside the room
    - Building floods during rain

1. New pump station building adjacent to existing pump station
2. New wet well and pumps (raw sewage, RAS, WAS), appurtenances and controls
3. Remove existing pumps and repurpose station building to be the main electrical building

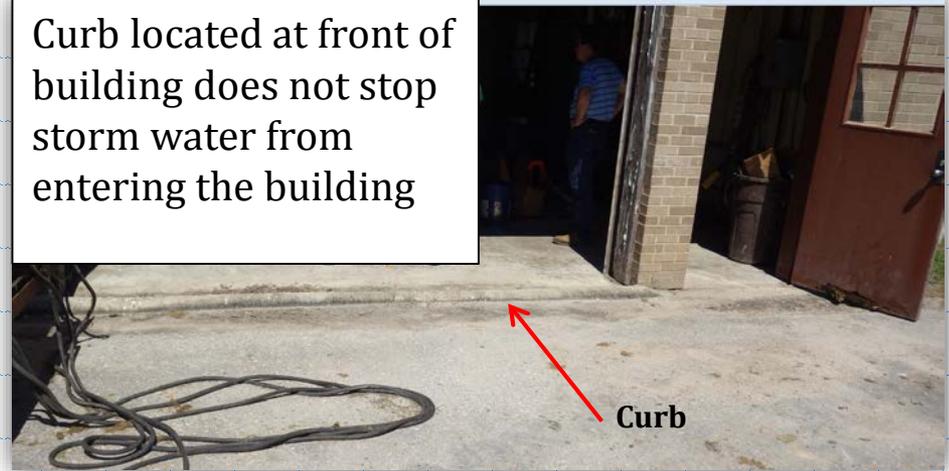
Curb located at front of building does not stop storm water from entering the building

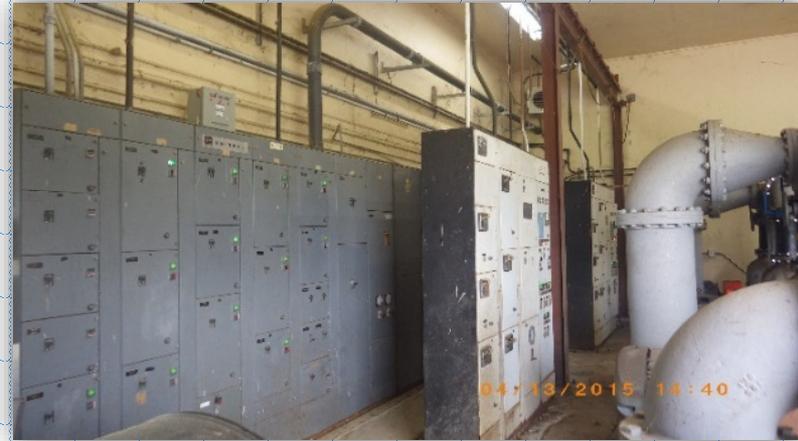
Electrical Equipment inside Pump Station

- Equipment past life expectancy
    - Flooding in room causes corrosion & safety hazard
    - Controllers outdated
    - Repairs cannot be made

- No HVAC present to protect MCCs
    - Heaters do not work
    - Fan put in the wall for exhaust
    - Portable fan sits on floor to cool electrical equipment

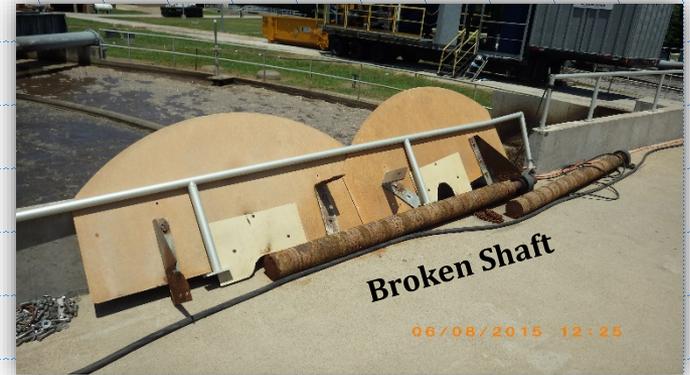
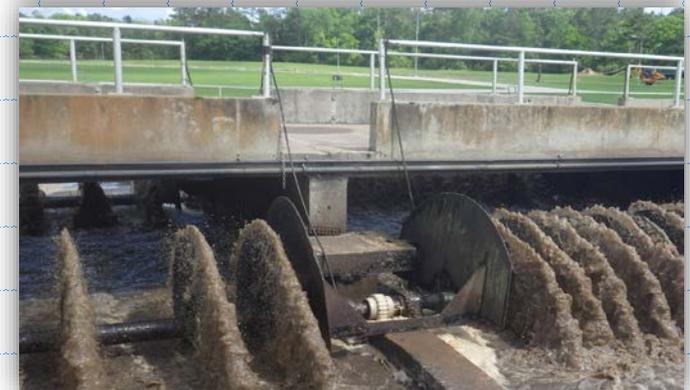
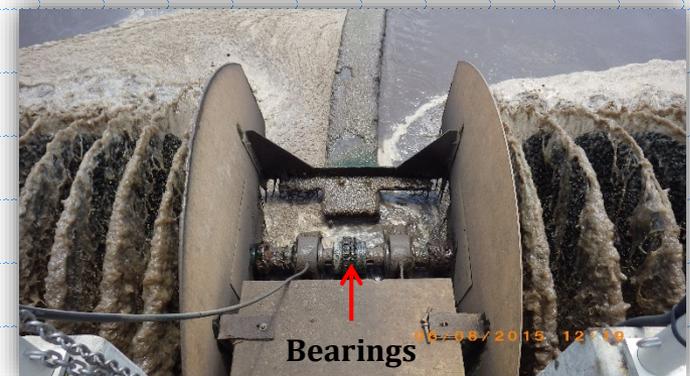
- Bearings wear frequently. Replaced 2-3 months
    - Shafts break due to vibration
    - Several aerator discs replaced already
    - Difficulty/safety hazard in replacing the bearings
    - Corrosion of piping

- Spalled Concrete on railing posts
    - Bent railing
    - FRP Bridge is delaminating

- One aerator has broken flux conduit - Basin 1
    - Motor disconnects not available - Basin 1
    - Conduit broke loose from motor box - Basin 2

### *Option 3: Conventional fine bubble aeration system*

- Build new conventional aeration basins
- Fine bubble diffusers
- New blowers
- New land area
- Designed for future stringent nutrient limits
- Existing mechanical aeration system will be abandoned

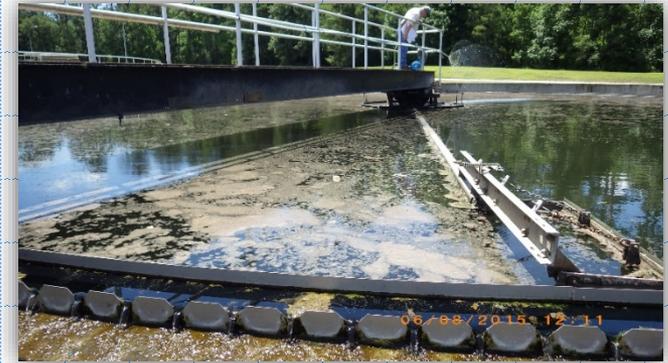
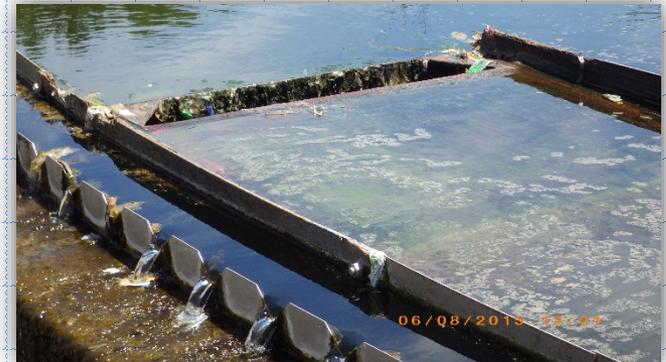
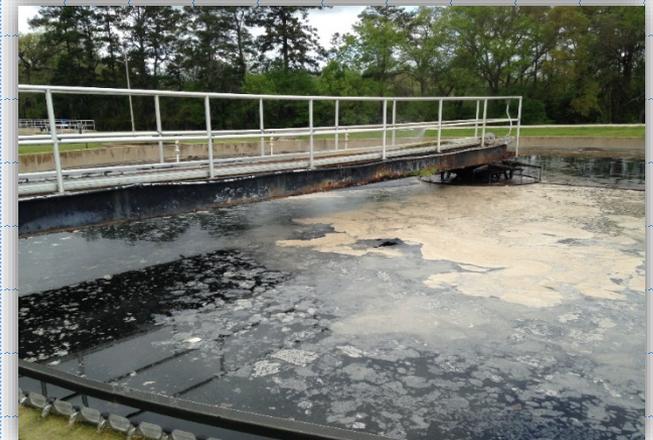
- Periodic sludge floating issue
- Scum trough and arm are old and rusted

- Scum scraper is old and rusted
- Scum baffle is new

- Receptacles not functional
- PVC conduit exposed to sun & supports broken

- Clarifier No.1 bridge framing in very poor condition

- Recommended Improvements
  - Add Stamford baffles
  - Replace scum scrapper arm and trough
  - Replace corroded access bridge and frame in clarifier no. 1

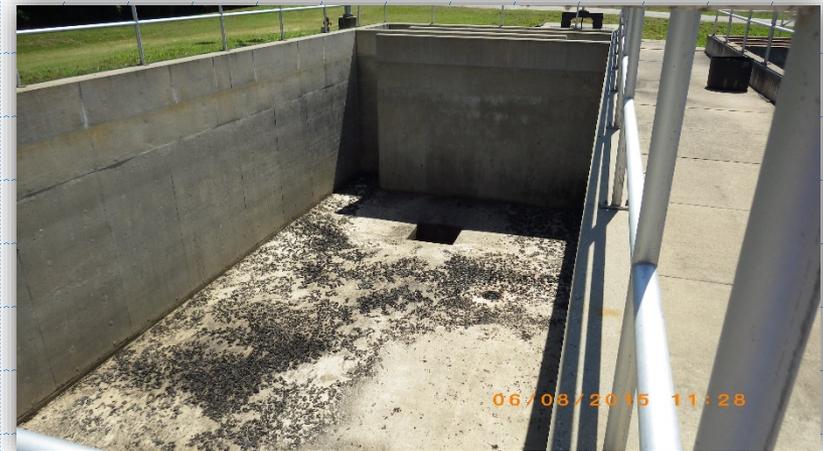
- Chamber is not in service
    - Flow not getting full 20 min contact time

- Recommended Improvements
  - Add curtain baffles to contact Basin No. 3 to prevent short circuiting
  - Add scum baffle to Basin No. 3 to catch the floatables

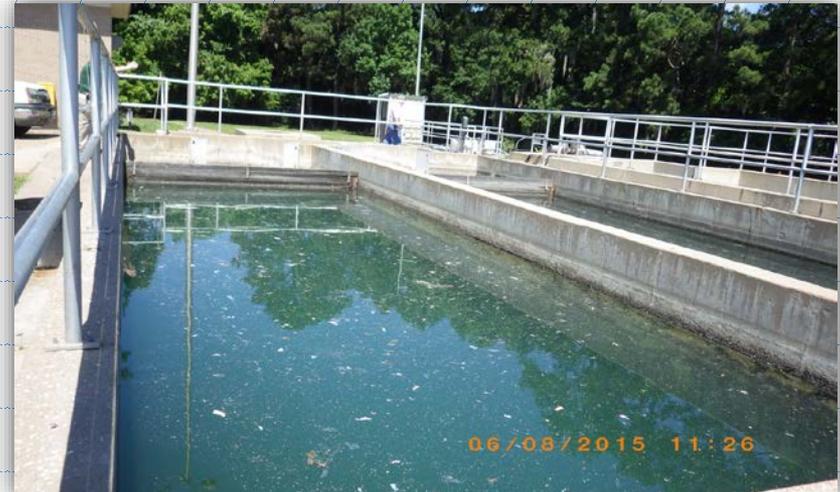
Basin No. 1 and 2

- Floors do not drain properly
    - No major issues

- Minor spalling of past concrete repairs

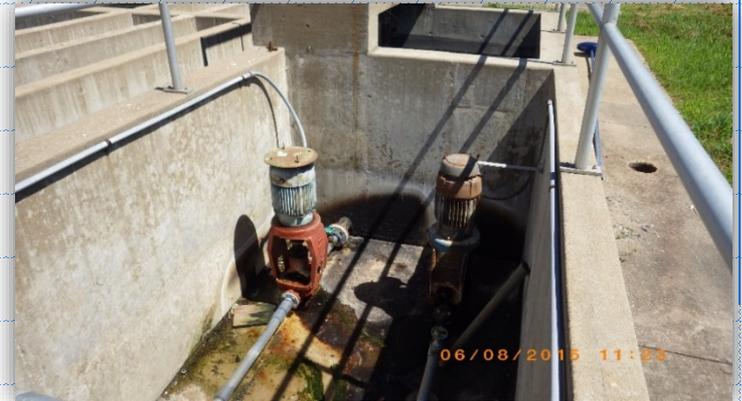
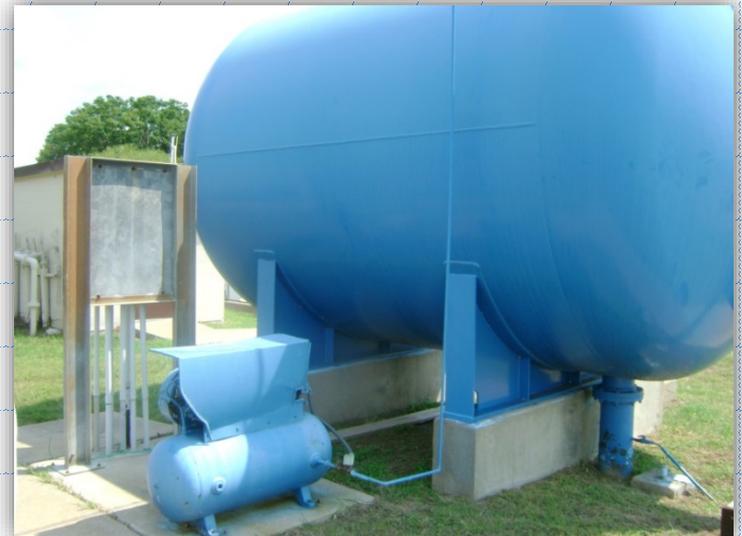
- Existing Facility Information
  - Year Installed: 1981
  - No. of Pumps: 2
  - One pump replaced recently
  - Hydro-pneumatic tank not functional
- Recommended Improvements
  - Replace old NPW pump
  - Install a new hydro-pneumatic tank

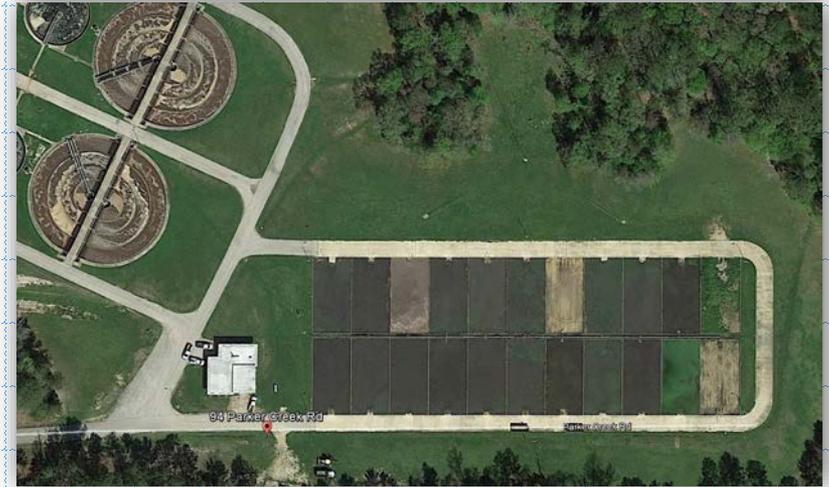
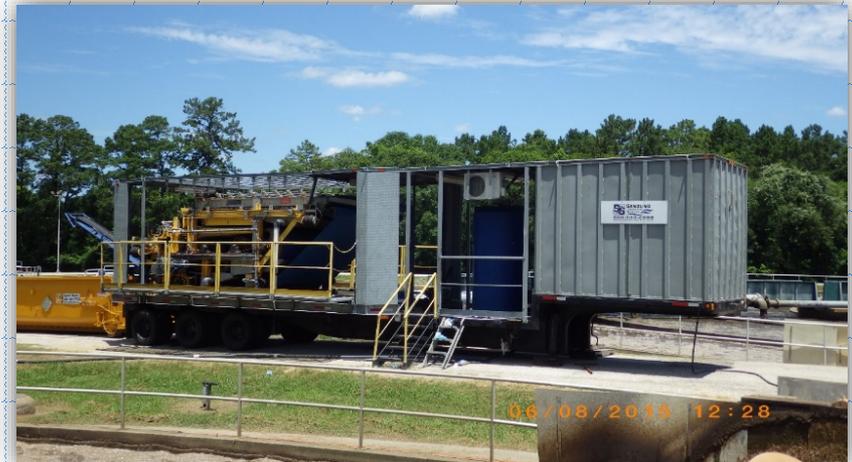
- Existing Facility Information
  - Waste activated sludge pumped to sludge drying beds
  - Total of 22 beds
- Existing Condition
  - Lose sludge drying capability during wet weather
  - City had to rent belt press to dewater solids after heavy rain in May
  - Minor concrete spalling
  - Few cracks in containment wall

- Improvement Alternatives
  - Install new mechanical dewatering equipment.
  - Two options for mechanical dewatering:
