City of Huntsville

PALM STREET WATER PLANT

CONDITION ASSESSMENT

November 10, 2015

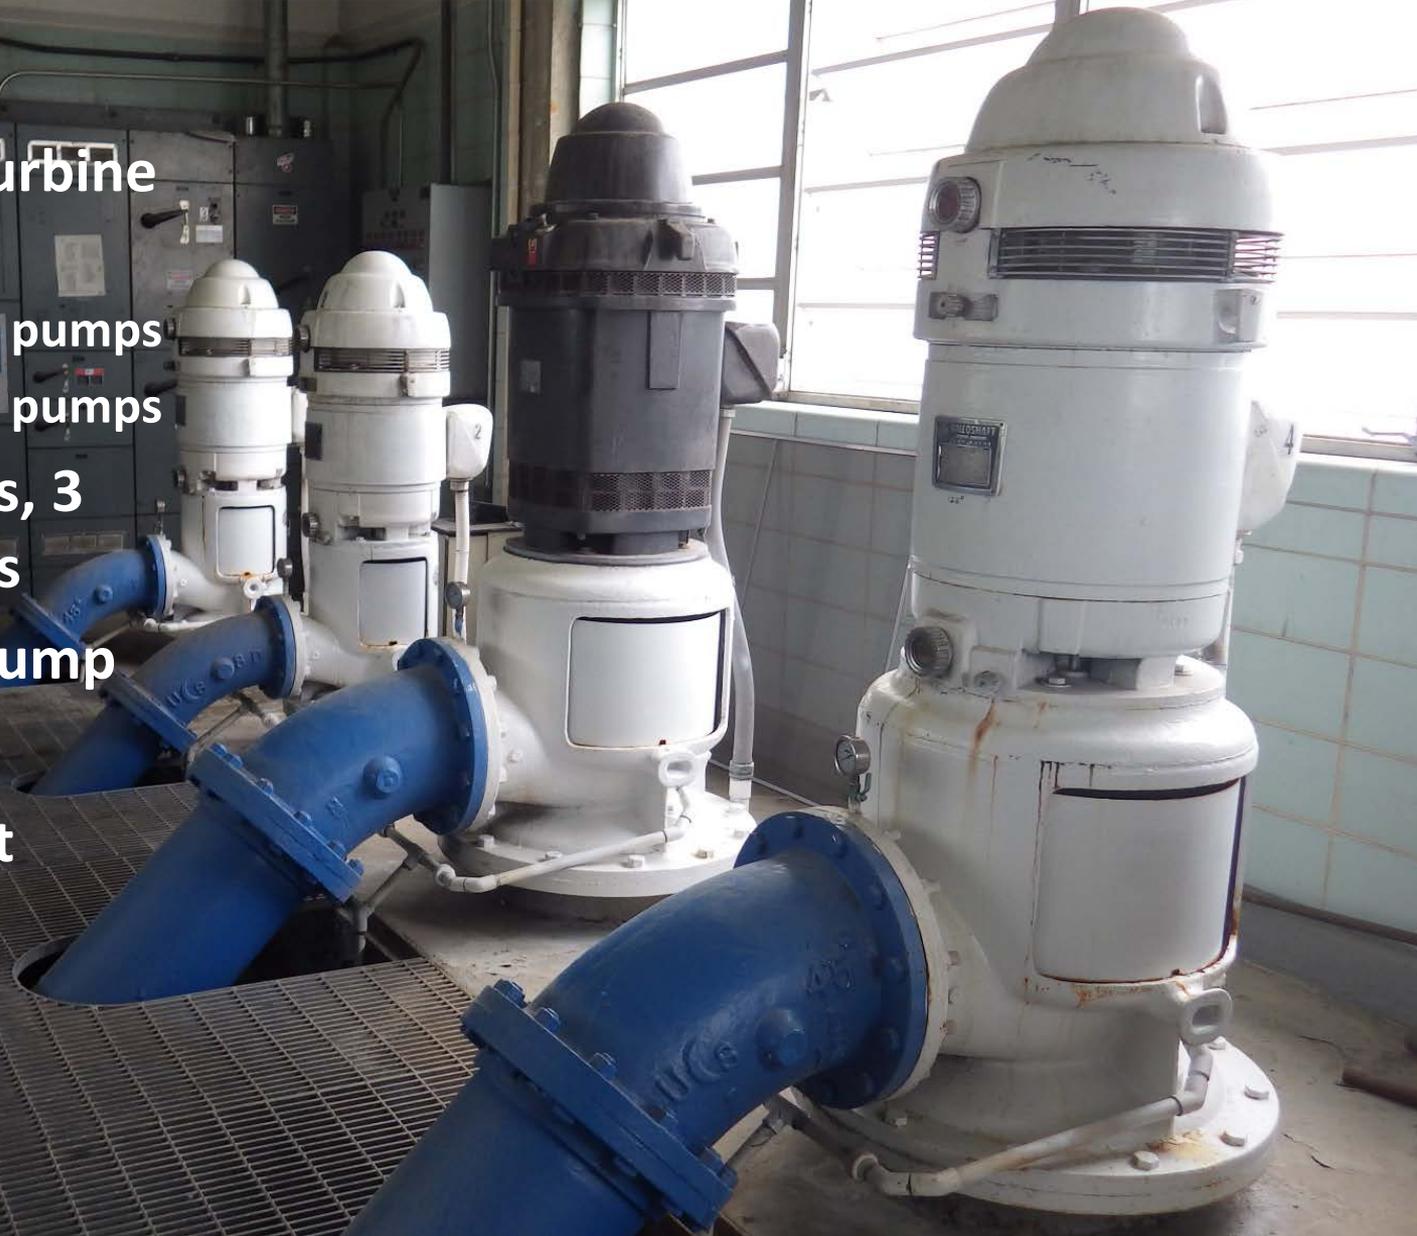
Old Pump Station Overview

- Built in 1960
- Four vertical turbine pumps
 - 2 - 1,000 gpm pumps
 - 2 - 2,000 gpm pumps
- Original pumps, 3 original motors
- Space for 5th pump
- Access Issues
- Small footprint

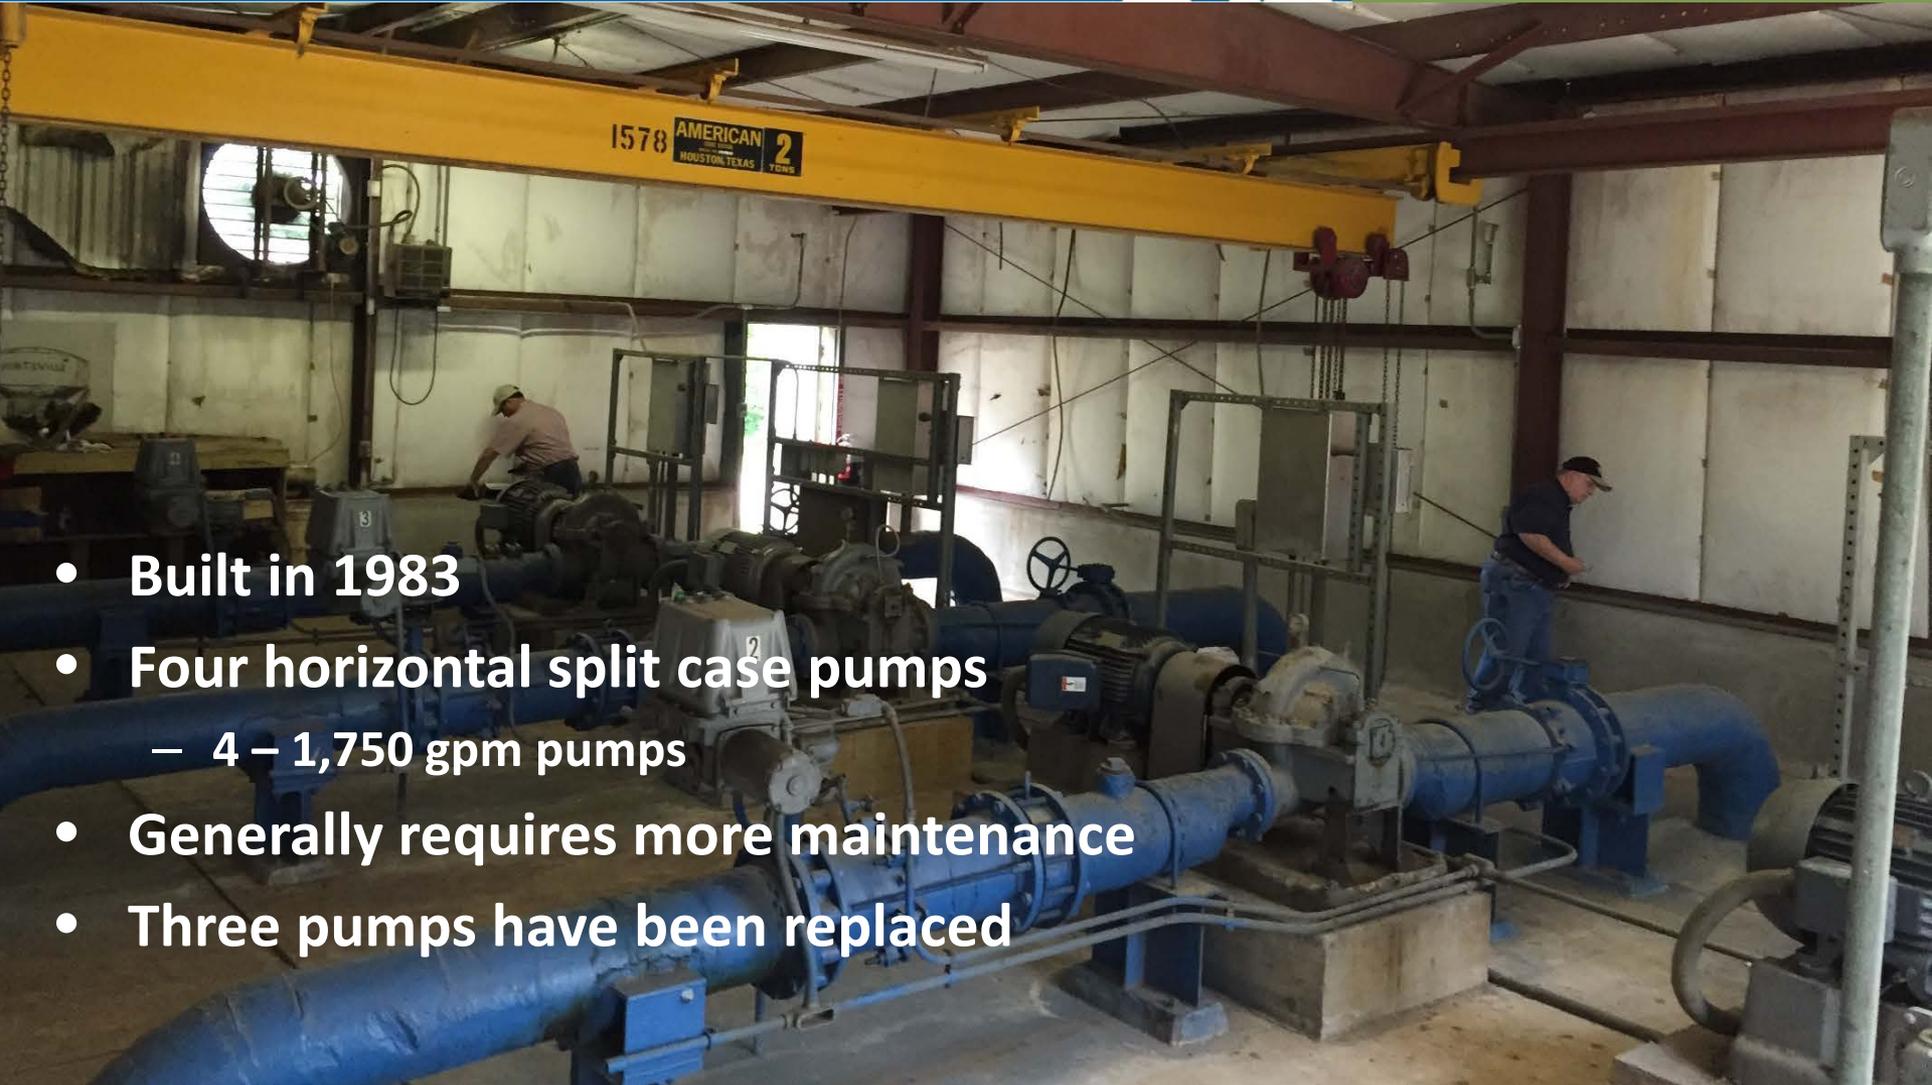
New Pump Station

- Built in 1983
- Four horizontal split case pumps
 - 4 – 1,750 gpm pumps
- Generally requires more maintenance
- Three pumps have been replaced
