# **A.J. Brown Wastewater Treatment Plant Condition Assessment**

**November 16, 2015**

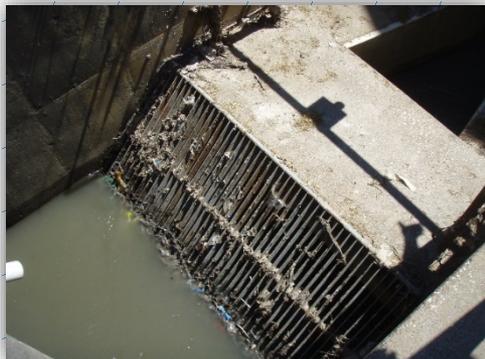
Manual Bar Screen

- Existing Conditions
  - Mechanical Screen
    - Screen in good condition
    - Occasional over torquing
  - Inlet Gate
    - Gate hung on a rod supported on the handrails
    - Manually lifted with a crane
  - Manual Bypass Screen
    - Difficult to get the screenings out of the channel
    - Safety Concerns – No handrails upstream and downstream

1. Replace existing inlet gate hung on pole with a slide gate for easier operation
2. Provide handrails at the manual bypass screen

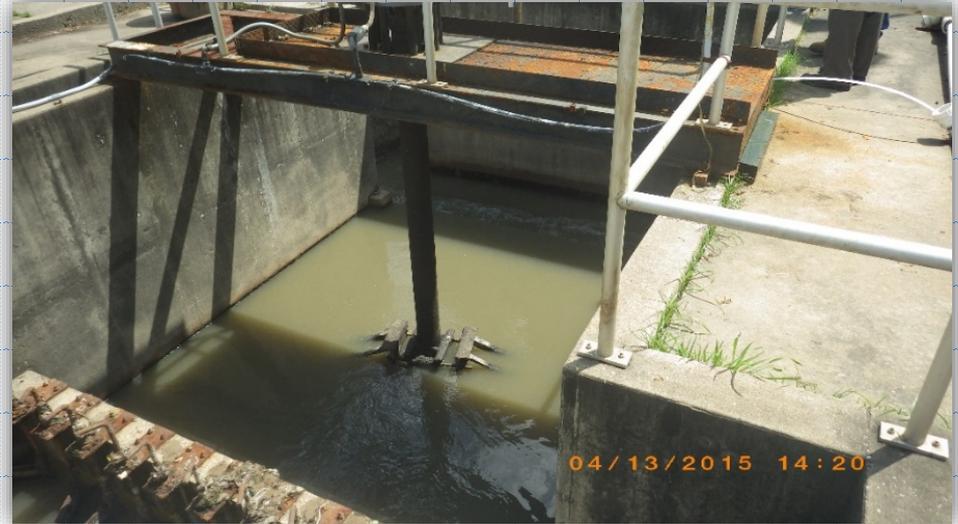
Detritor

- System functional but reaching end of useful life
    - Corrosion of inlet baffles and screw conveyor

1. Replace existing detritor with gravity vortex grit removal system – HeadCell™ in the future

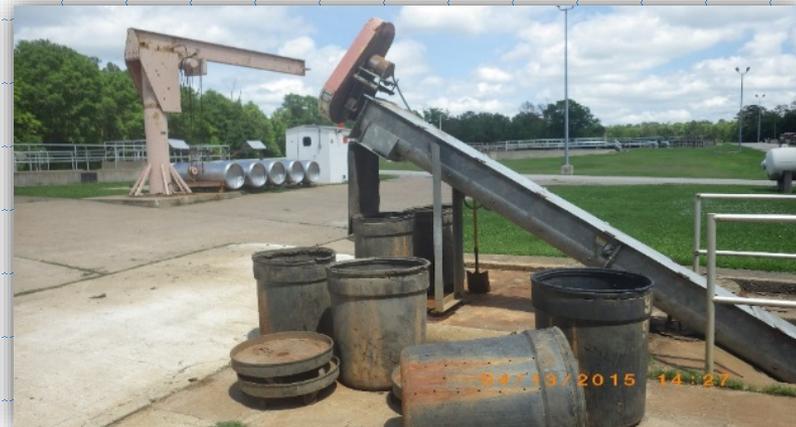
Screw Conveyor

- Flex conduits are corroding
    - Push button station aging at screw & grit motor
    - MCC past life expectancy of 30 years
    - Screw motor shows corrosion

1. Replace motor access bridge/ walkway
2. Repair damaged/ broken railings
3. Replace MCC and push button at screw and grit motor

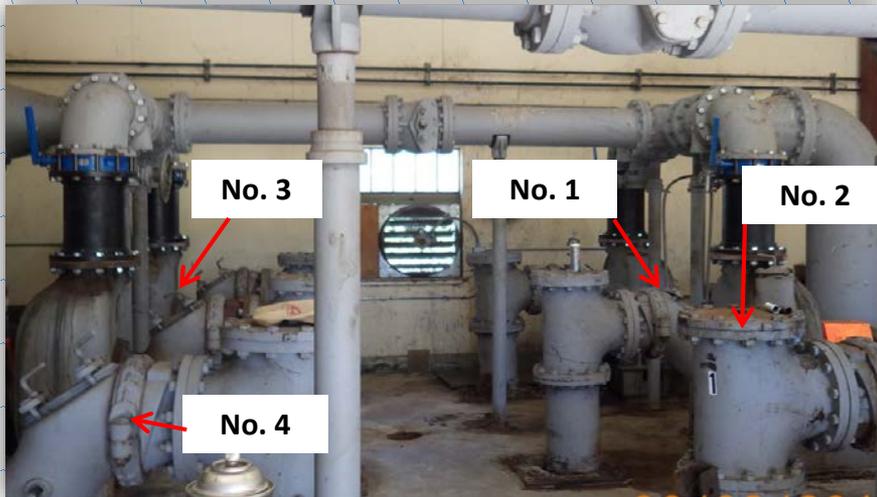
Raw Sewage Pumps

- Seals are leaking
    - Volutes show severe wear and tear and leakage
    - All motors have been (except pump no. 1) have been replaced over the years
    - Frequently have to be taken out of service for repair
    - Pumps are past their useful life

- No proper drainage inside the room
    - Building floods during rain

1. New pump station building adjacent to existing pump station
2. New wet well and pumps (raw sewage, RAS, WAS), appurtenances and controls
3. Remove existing pumps and repurpose station building to be the main electrical building

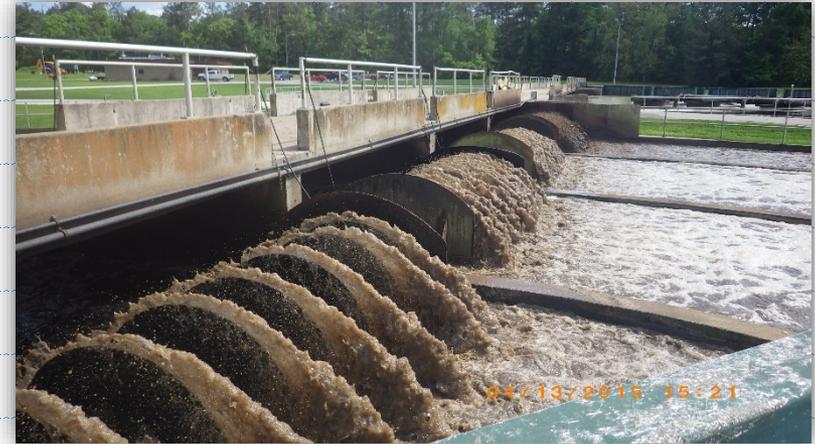
Aeration Basin No. 1

- Bearings wear frequently. Replaced 2-3 months
    - Shafts break due to vibration
    - Several aerator discs replaced already
    - Difficulty/safety hazard in replacing the bearings
    - Corrosion of piping

- Spalled Concrete on railing posts
    - Bent railing
    - FRP Bridge is delaminating

- One aerator has broken flux conduit - Basin 1
    - Motor disconnects not available - Basin 1
    - Conduit broke loose from motor box - Basin 2

- Build new conventional aeration basins
- Fine bubble diffusers
- New blowers
- New land area
- Designed for future stringent nutrient limits
- Existing mechanical aeration system will be abandoned

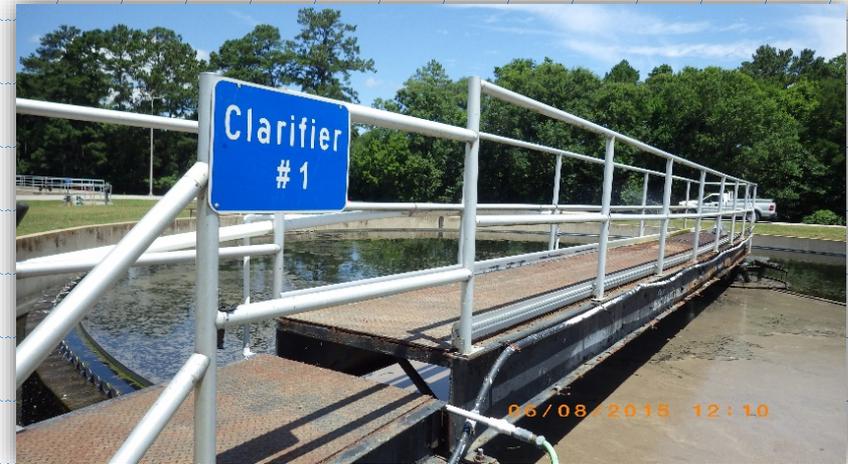
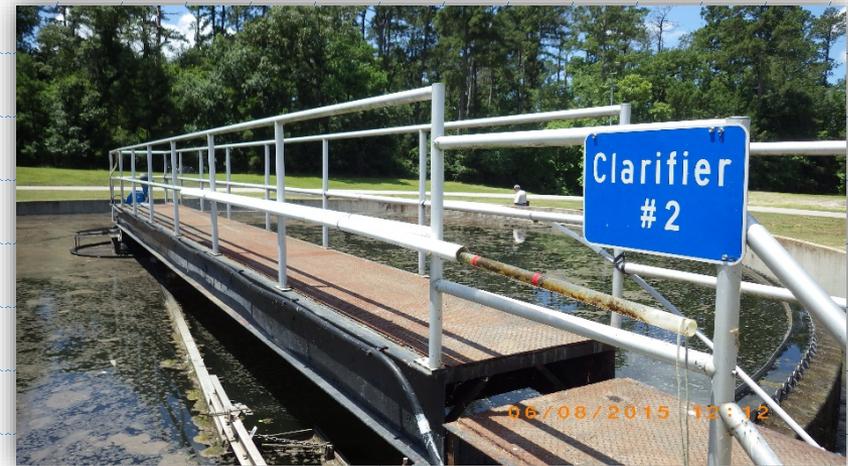
- Periodic sludge floating issue
- Scum trough and arm are old and rusted

- Scum scraper is old and rusted
- Scum baffle is new

- Receptacles not functional
- PVC conduit exposed to sun & supports broken

- Clarifier No.1 bridge framing in very poor condition

- Recommended Improvements
  - Add Stamford baffles
  - Replace scum scrapper arm and trough
  - Replace corroded access bridge and frame in clarifier no. 1

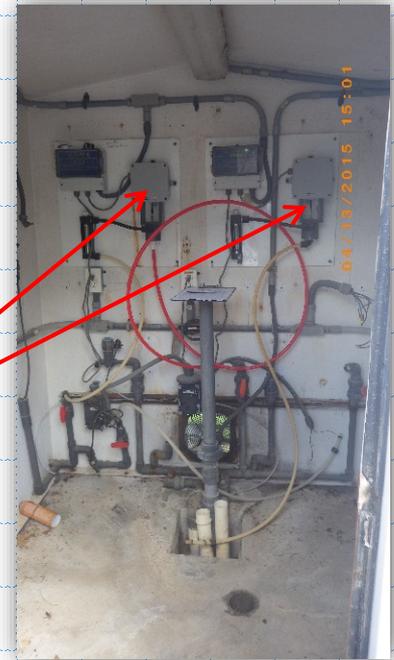
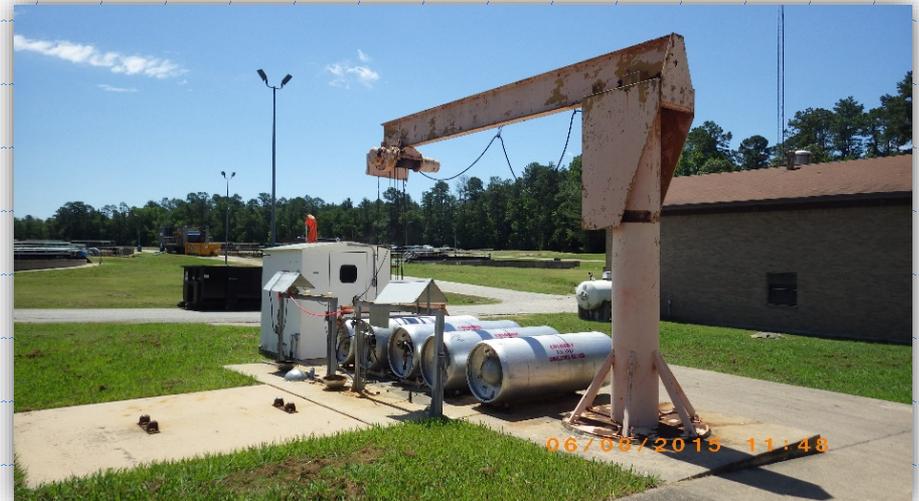
Chlorinators

- Existing Facility Information
  - Number of Chlorinators: 2
  - Capacity: 500 lbs/day each
  - Chlorine ton cylinder stored outside
- Existing Condition
  - **Mechanical Equipment**
    - Only two scales for the ton cylinders
    - Cylinders are hard to switch with crane
  - **Electrical**
    - Push button station not reliable
  - **Structural**
    - Ton cylinder storage pad in good condition
    - 3 ton jib crane in fair condition  
needs painting

- Recommended Improvements
  - Provide building for chlorine ton cylinders

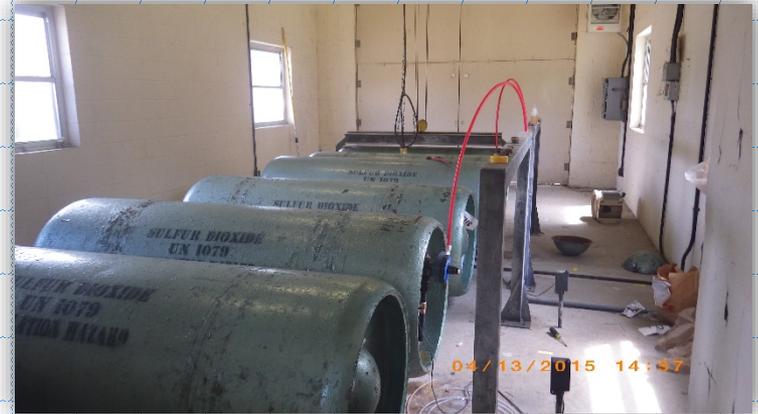
Dechlorination Building

- Existing Facility Information
  - Number of Sulfonators: 2
  - Capacity: 250 lbs/day each
  - Sulfonators located inside a building
  - Exhaust fan not working
- Recommendation
  - Replace exhaust fan

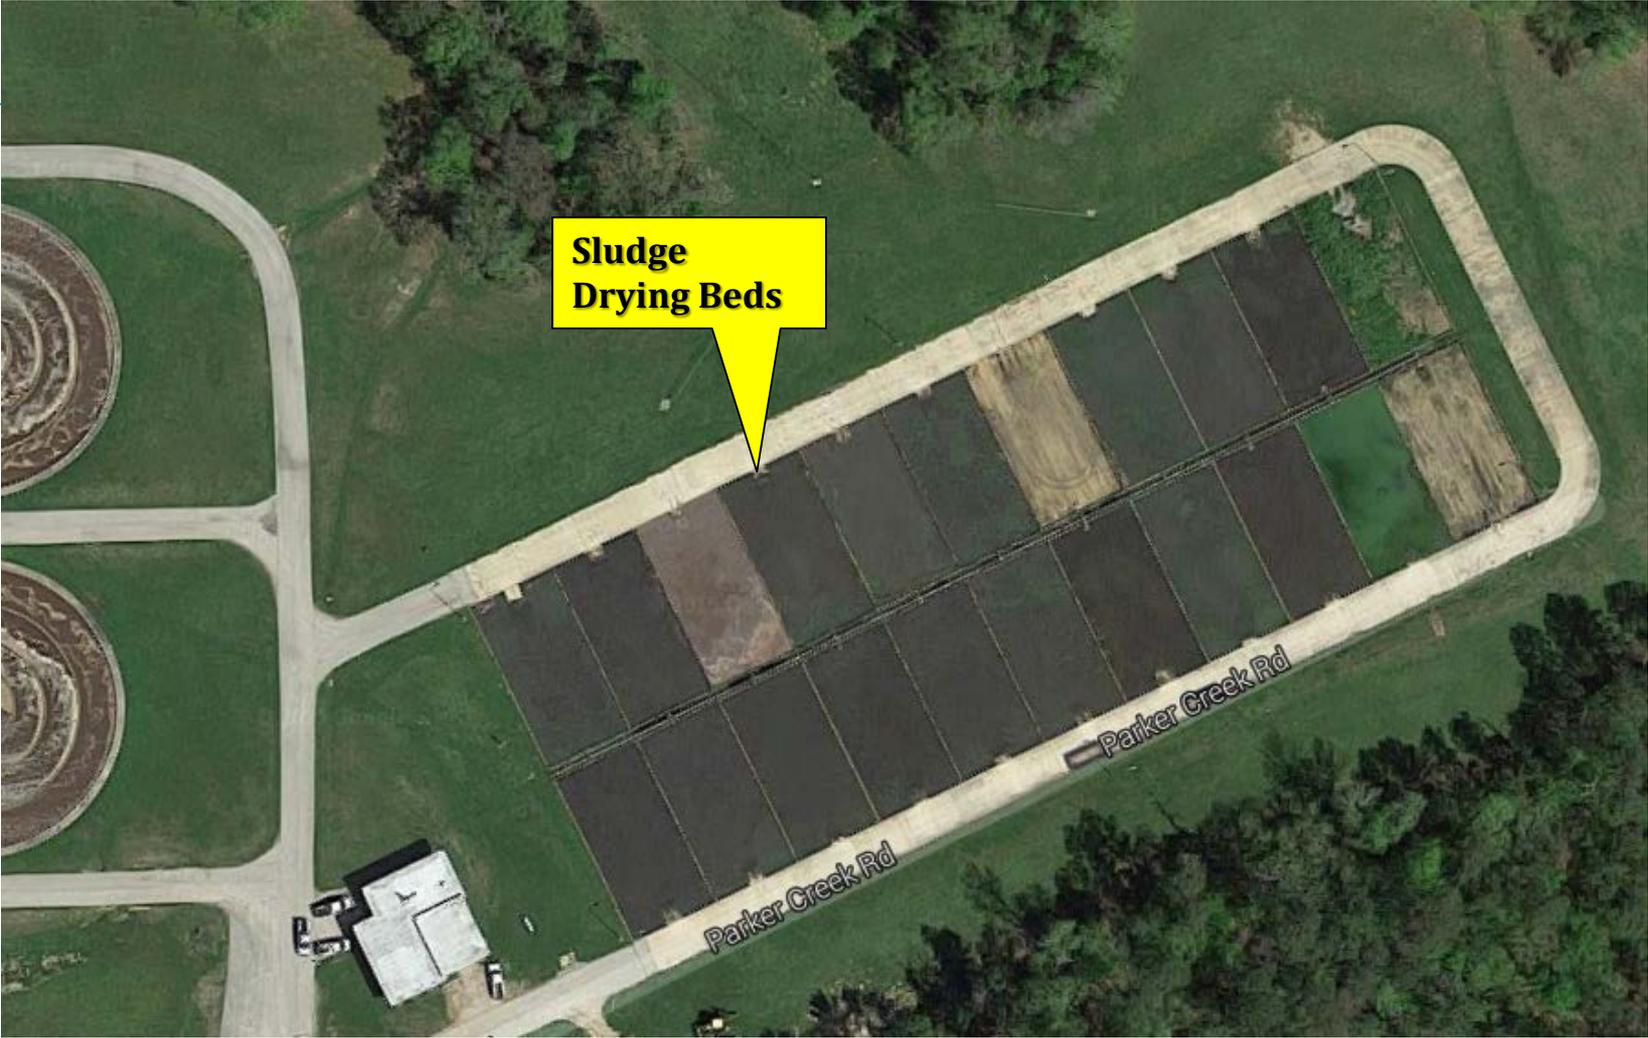
# Treatment Plant Evaluation – Sludge Drying Beds

- Existing Facility Information
  - Waste activated sludge pumped to sludge drying beds
  - Total of 22 beds
- Existing Condition
  - Lose sludge drying capability during wet weather
  - City had to rent belt press to dewater solids after heavy rain in May
  - Minor concrete spalling
  - Few cracks in containment wall

- Improvement Alternatives
  - Install new mechanical dewatering equipment.
  - Two options for mechanical dewatering:
